NATIONAL ADVISORY COMMITTEE FOR AERONAUTICS

TECHNICAL NOTE 2572

CERAMIC COATINGS FOR PREVENTION OF CARBON ABSORPTION
IN FOUR HEAT-RESISTANT ALLOYS

By Joseph W. Pitts and Dwight G. Moore

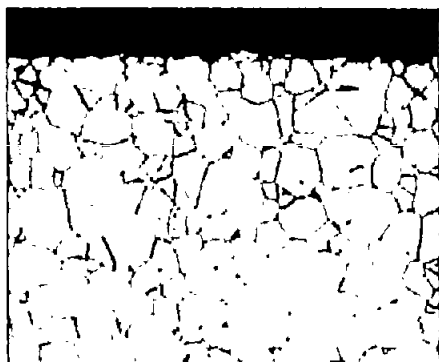
(a) Uncoated.

(b) Coated.

Figure 1.- Photomicrographs (X100, cupric-picral-nital etch) of sections through the surface of both coated (A-19H) and uncoated stainless-steel specimens after box carburizing for 4 hours at 1500° F.

Figures 1 and 2 are photomicrographs of sections taken through the surface of the three stainless steels after the carburizing treatments at 1500° and 1650° F, respectively. The upper picture in each case is the uncoated alloy while the lower picture is the same alloy that has been protected with A-19H. No carbide precipitation was noted with the Type 321 and Type 347 alloys after the carburizing treatment at 1350° F. The Type 304 steel did show the type of carbide precipitation that would be expected from an unstabilized steel after a sensitizing treatment of 4 hours at 1350° F. At the same time there was no evidence of a concentration of carbides near the surface such as would be expected if there had been an absorption of carbon.

Table 3 and figures 1 and 2 indicate that ceramic coatings qualify for this purpose. Of the three coatings studied, A-19H proved to be the most effective in preventing carbon absorption under all test conditions, but it should be pointed out that pack carburizing represents an extremely severe carburizing condition. In operation, carburizing gases from high fuel-air ratios are common in aircraft exhaust systems, especially during take-off and during flight at high altitudes. However, even under the highest fuel-air ratios encountered, the carburizing conditions would probably never reach the severity encountered in pack carburizing. Also, in aircraft exhaust systems, high gas velocities may cause flow of the coated material if the coating lacks sufficient refractoriness. For both of these reasons, the pack-carburizing treatment cannot be considered as a suitable test for coating selection and, at the present time, it is believed that the only reliable criterion for establishing the superiority of one coating over another is by the service testing of coated exhaust parts.

The Type 304 steel, which is unstabilized, showed carbide precipitation throughout its entire structure at all three carburizing temperatures. However, at 1500° and 1650° F there was evidence of carbon absorption into the steel surface and this was evidenced by a greater amount of carbide formation. As shown in figures 1 and 2, the line of demarcation representing the case depth due to carbon absorption was poorly defined, but the photomicrographs nevertheless illustrate that some carbon absorption has occurred with the uncoated steel. The same

figures show that this absorption has been prevented when the steel was protected with the A-19H coating.

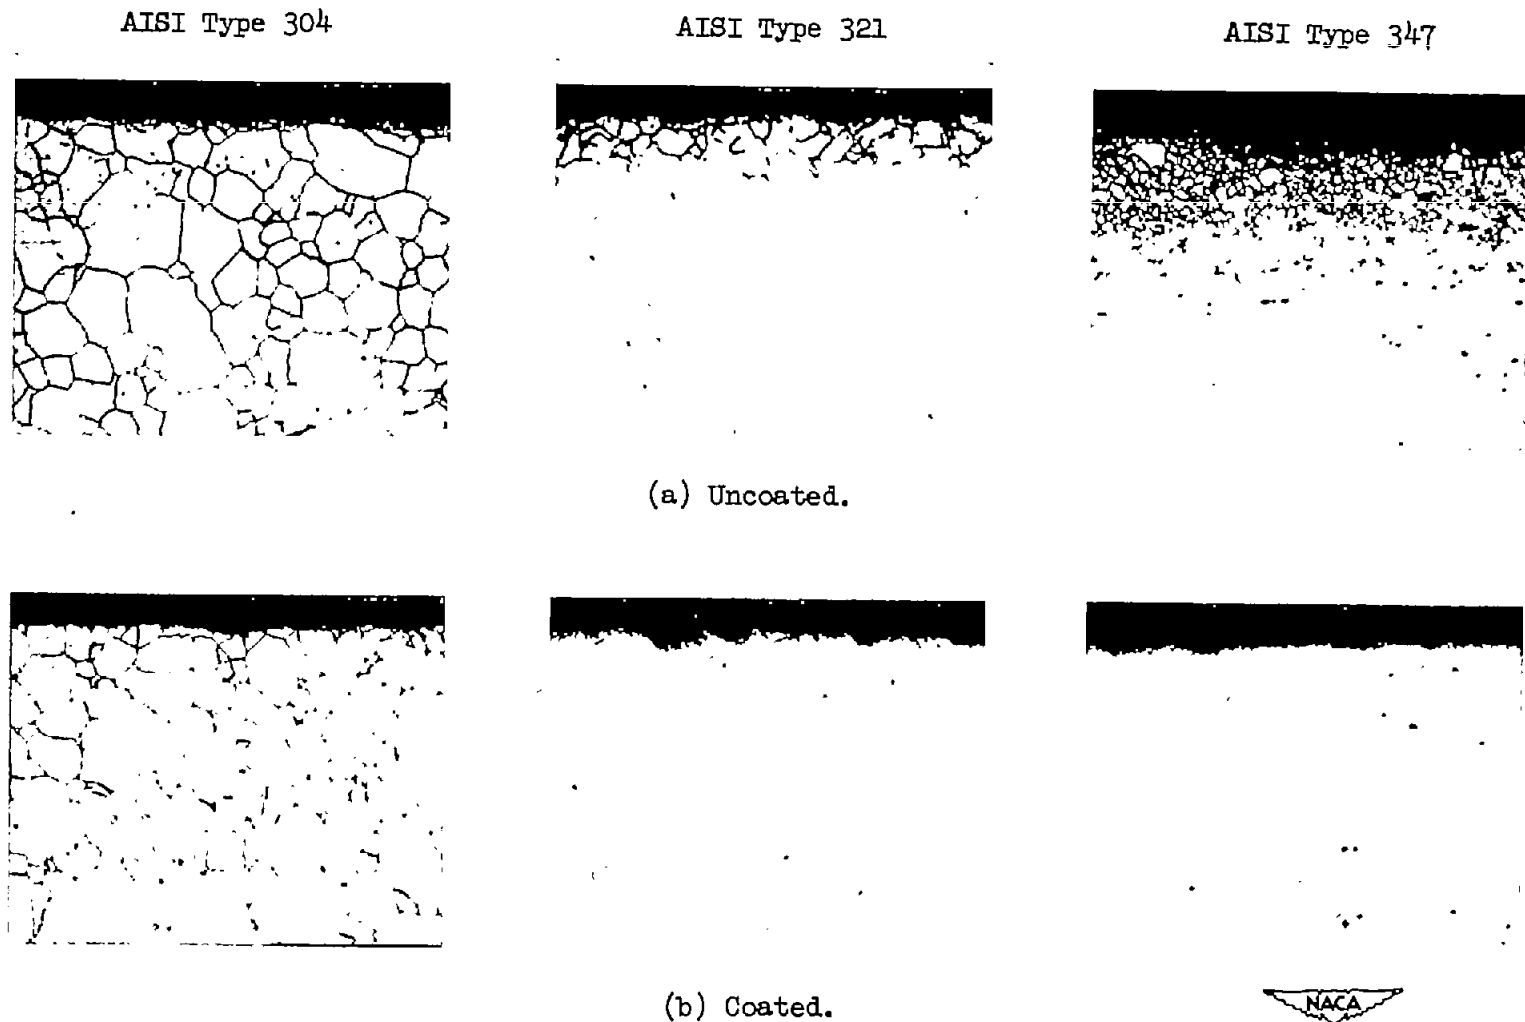
Figure 2.- Photomicrographs (X100, cupric-picral-nital etch) of sections through the surface of both coated (A-19H) and uncoated stainless-steel specimens after box carburizing for 4 hours at 1650° F.

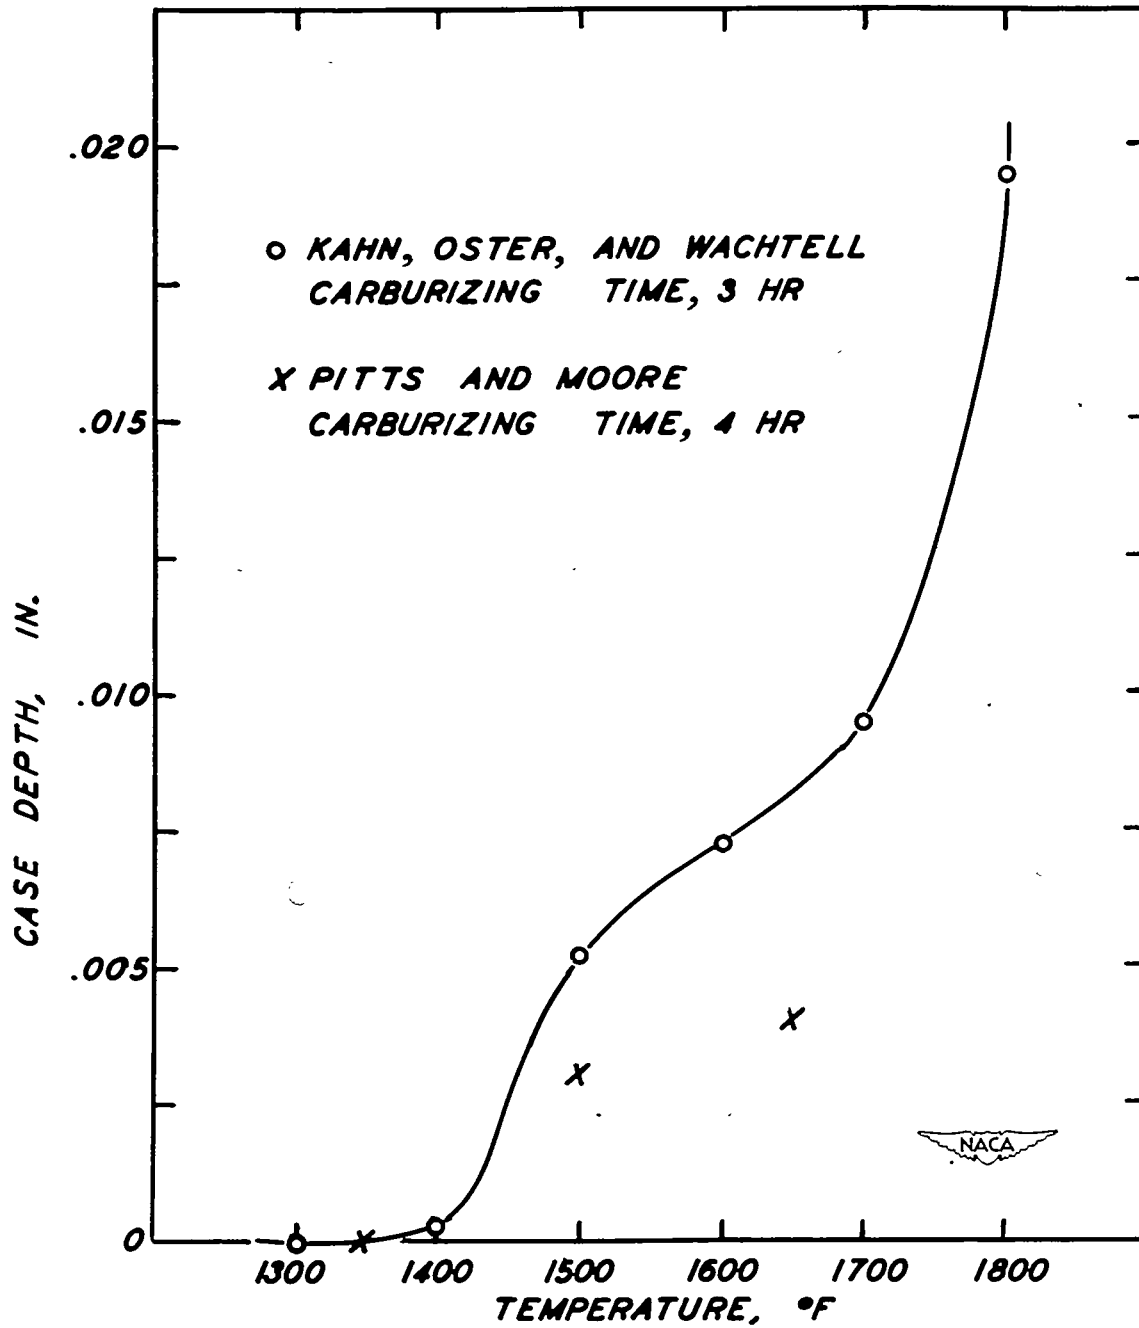
Figure 3.- Case depth plotted against temperature for AISI Type 321 stainless steel after box carburizing for the times indicated. Case depth represents average depth to which alloy showed carbide precipitation at grain boundaries.

Figure 3 is a curve of case depth plotted against temperature for Type 321 stainless steel as taken from the paper by Kahn, Oster, and Wachtell (reference 5). Points representing data from the present study are included for comparison.

promote carbon absorption in the alloys and the same etchant was used to bring out carbides. Figure 3 shows that only fair agreement was obtained for the Type 321 alloy which was the only alloy studied by the aforementioned authors. There is good agreement at 1350° F but at 1500° F smaller case depths were obtained in the present study although a longer carburizing time was used. The cause of this discrepancy may be due to differences in the carburizing compounds or to minor differences in the steels.
